NATIONAL AERONAUTICS AND SPACE ADMINISTRATION

APOLLO 10 MISSION REPORT

MANNED SPACECRAFT CENTER

AUGUST 1969

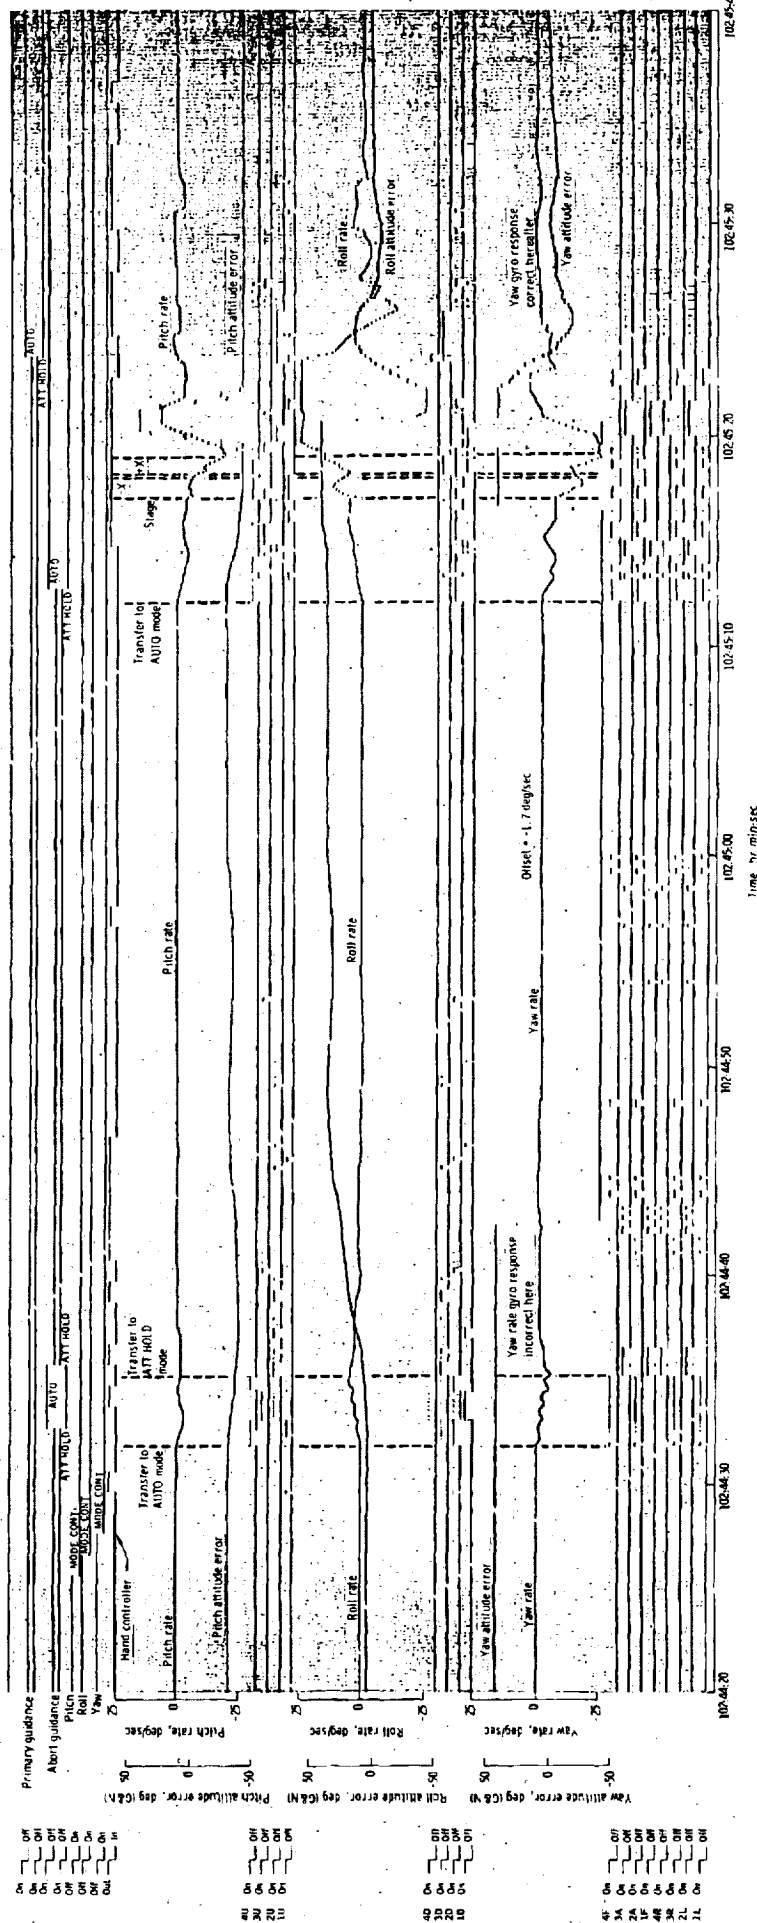
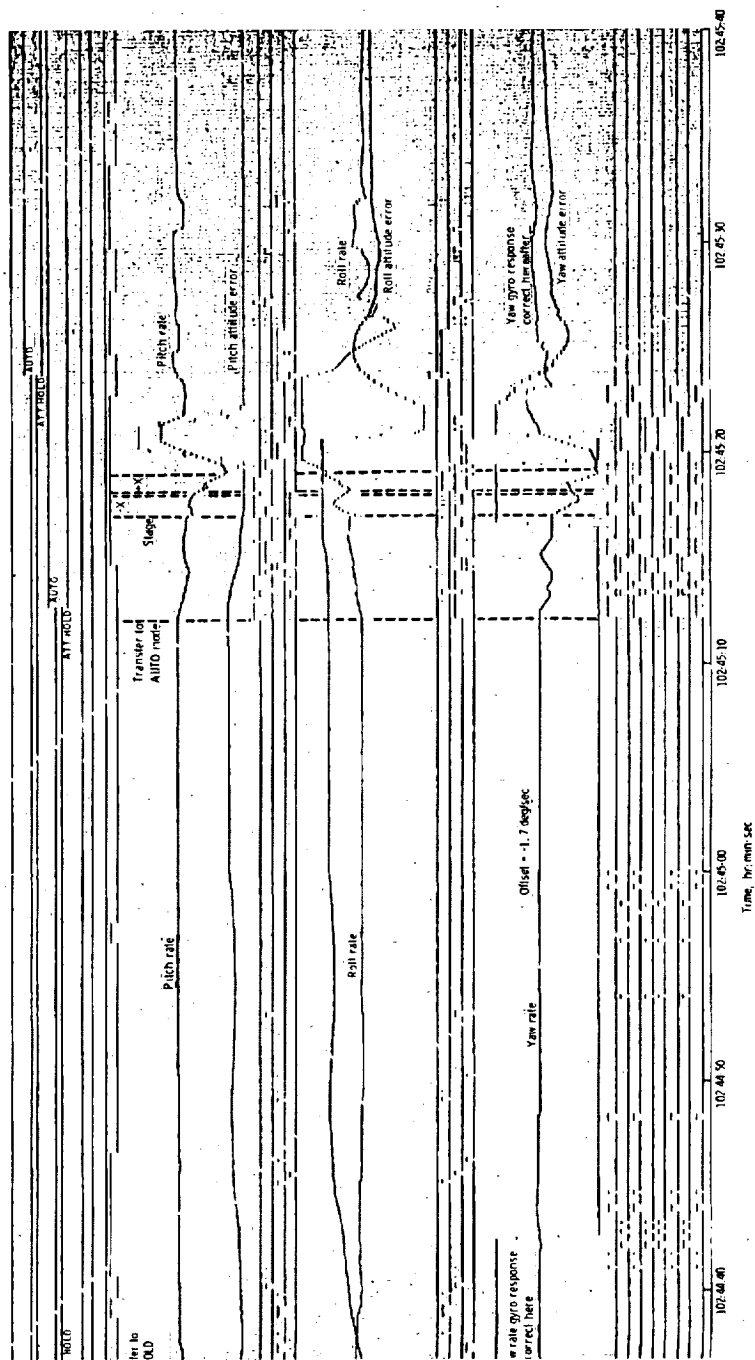
Figure 15-40. Dynamics at staging.

Large attitude excursions occurred prior to and during staging (fig. 15-40). Body rates of 19 deg/sec in pitch and greater than 25 deg/sec in roll and yaw were recorded. Smaller attitude excursions occurred approximately 40 seconds prior to staging. The mode switching, telemetry, and associated attitude commands indicate that the abort guidance mode changed from ATT HOLD to AUTO coincident with the vehicle gyrations.

The attitude control switches were sequentially thrown to MODE CONT, as shown in figure 15-40, 51 seconds before staging. Five seconds after the selection of MODE CONT, the mode control switch indication changed from ATT HOLD to AUTO, remained in AUTO for 3 seconds, then returned to ATT HOLD. During this period, the vehicle moved in all three axes in response to Z-axis steering commands. After the mode indication returned to ATT HOLD, the dynamics again returned to normal for wide deadband. (Note: The yaw rate gyro output was incorrect during this period, as shown in figure 15-40 and discussed elsewhere in this report. The gyro problem was properly diagnosed by the crew after a number of hand controller operations.) After approximately 40 seconds, the mode indication again returned to AUTO, and the vehicle responded to Z-axis steering commands. The vehicle was staged 4 seconds later, and the dynamic response increased abruptly. The data indicate that staging was coincident with a minus X translation and that the primary guidance system mode control switch was thrown to AUTO 7 seconds later. Because of the relative scaling of the hand controller, rate gyros, and attitude errors, attempts to manually control the motion were ineffective, and the vehicle stabilized with the Z-axis pointing toward the command module. Approximately 24 seconds after staging, the attitude control switches returned to DIR, and the two mode control switch indications returned to ATT HOLD.

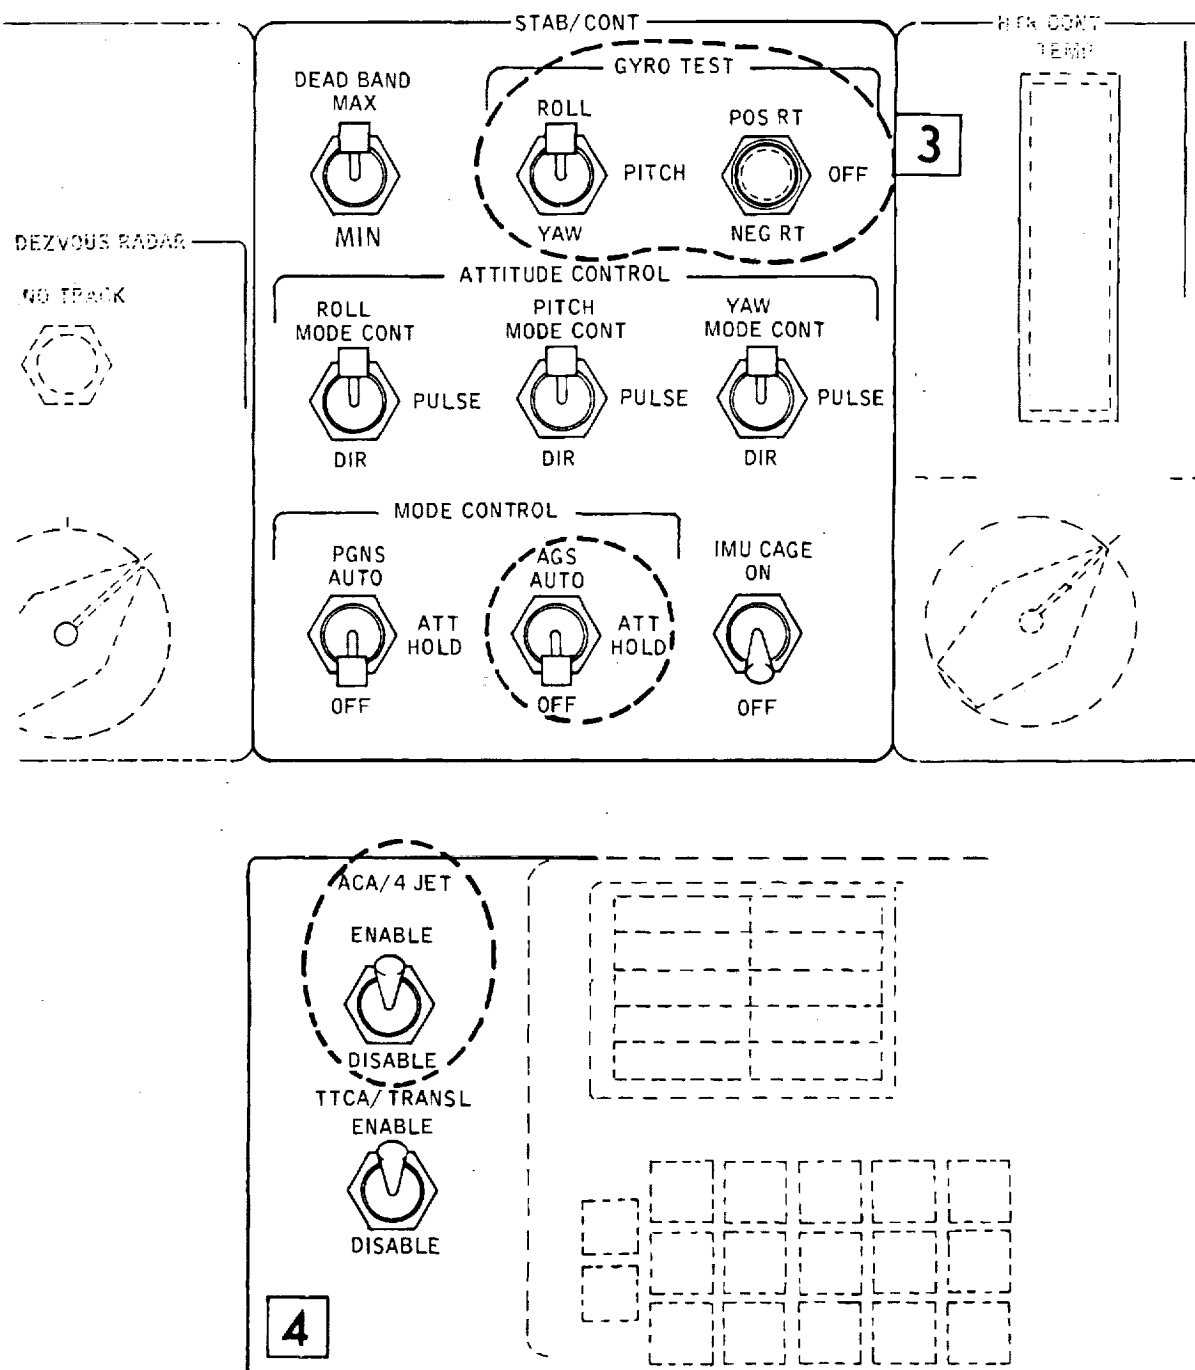
Figure 15-41. - Lunar module guidance switch locations.

The attitude control switches on panels 3 and 4 are shown in figure 15-41, and a simplified functional switching diagram is shown in figure 15-42. Approximately 4 minutes before staging, with the guidance select switch in AGS and the attitude control switches in PULSE, the crew verified that the abort guidance mode control switch was in ATT HOLD since the intent was to perform staging in AGS ATT HOLD. After some discussion, they selected MAX deadband to save propellant.

Switches.— Functions in each of the anomalous areas are controlled by switches (see fig. 15-41).

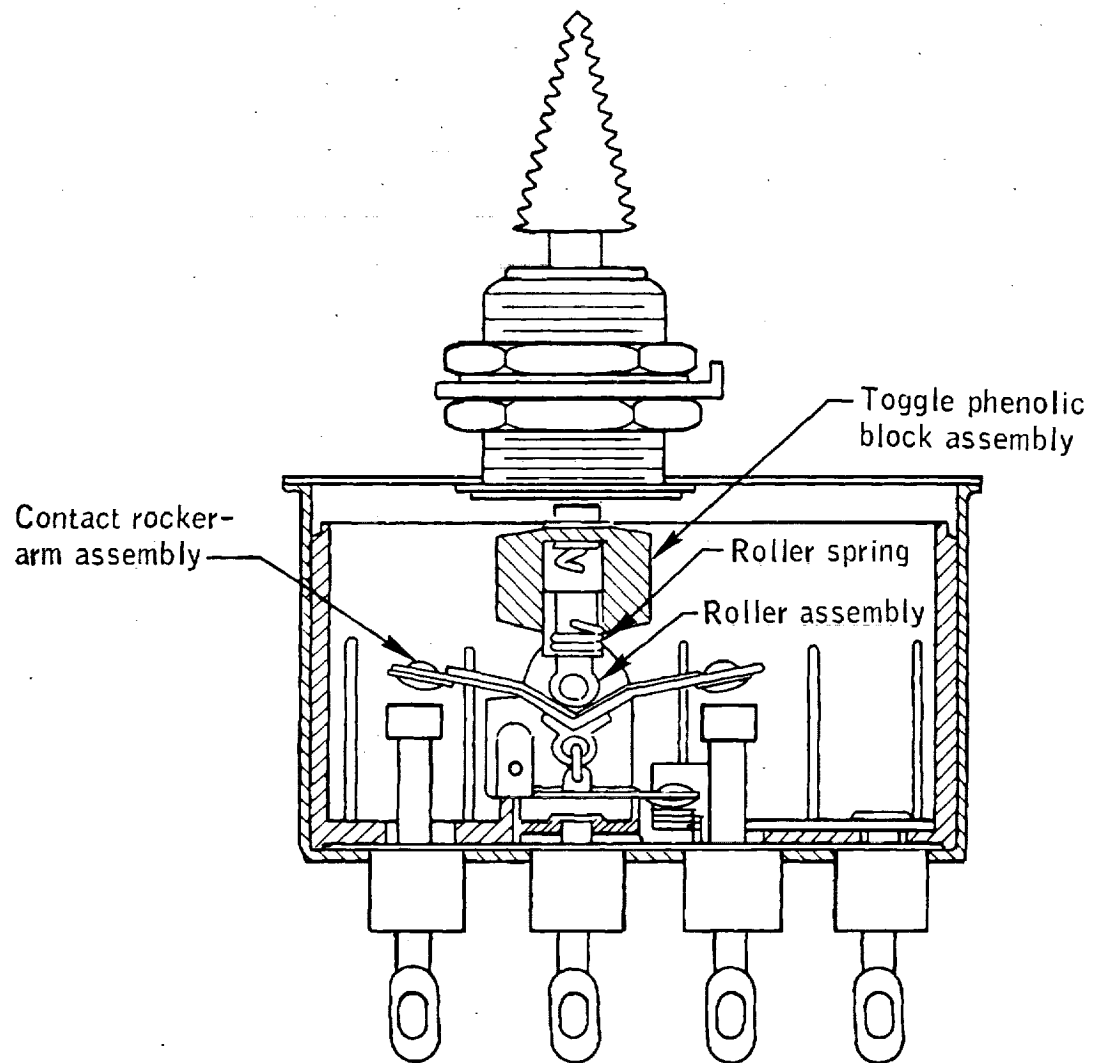
Figure 15-43.- Abort guidance mode control switch.

The abort guidance system mode control switch, on panel 3, was used several times before and after staging with no evidence of abnormality. To produce the flight results requires the contacts to transfer on at least two of the three poles of this switch. No known failure modes in the switch would produce this type of failure. Two failure modes postulated would allow the contact rocker arms to become free-floating. However, testing under a simulated flight environment has shown that because of frictional forces at the contact arm pivot point, the free-floating contacts will not transfer (see fig. 15-43). The observed anomaly would have required the simultaneous motions of two rocker arms.

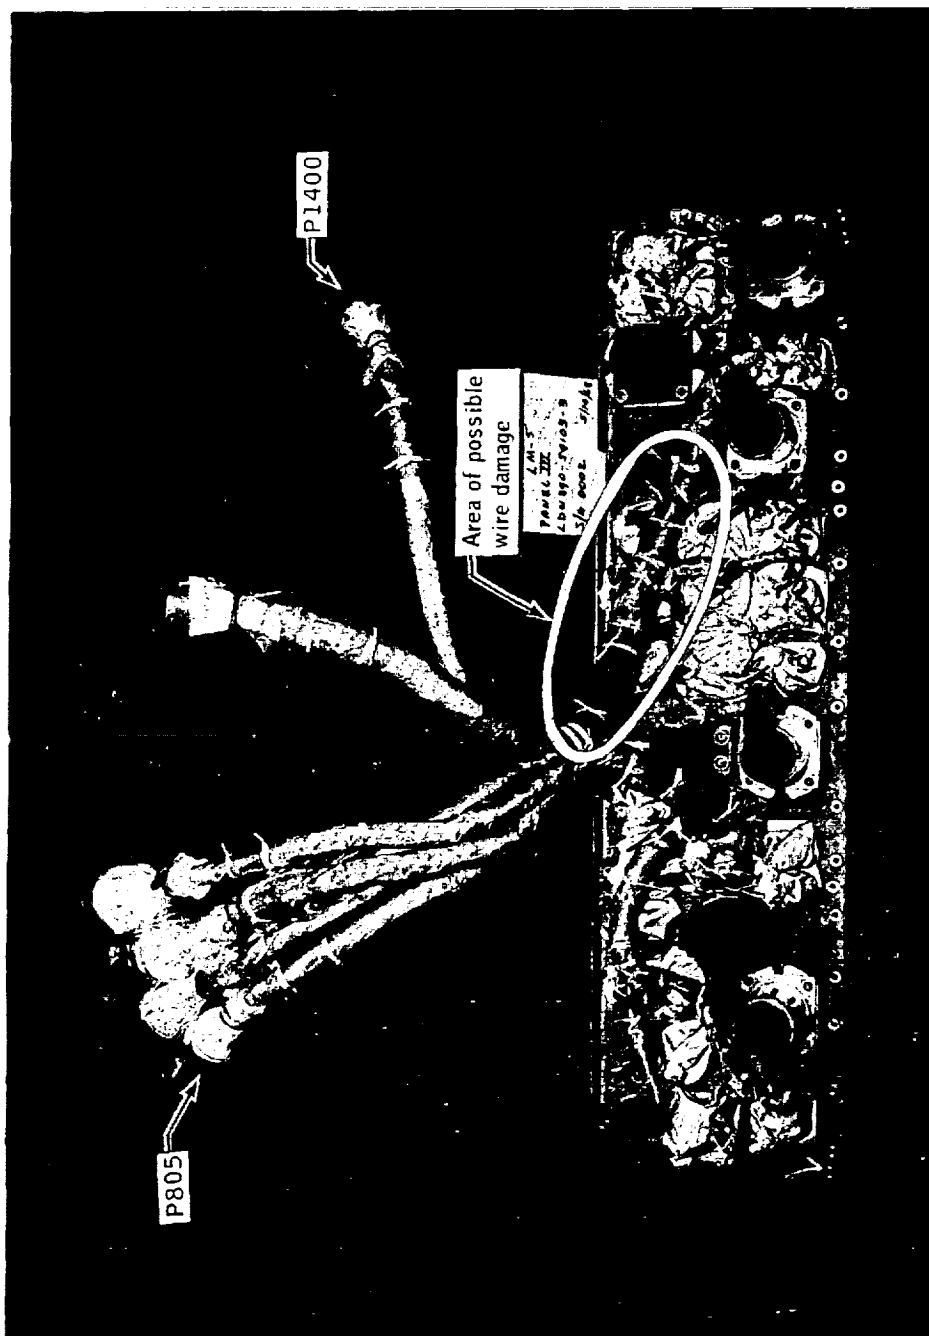
Figure 15-44.- Panel 3 wiring.

Wiring.— Four inches of electrical wiring contained in a single wire bundle behind panel 3 is the only point common to all the anomalous circuits (see fig. 15-44).

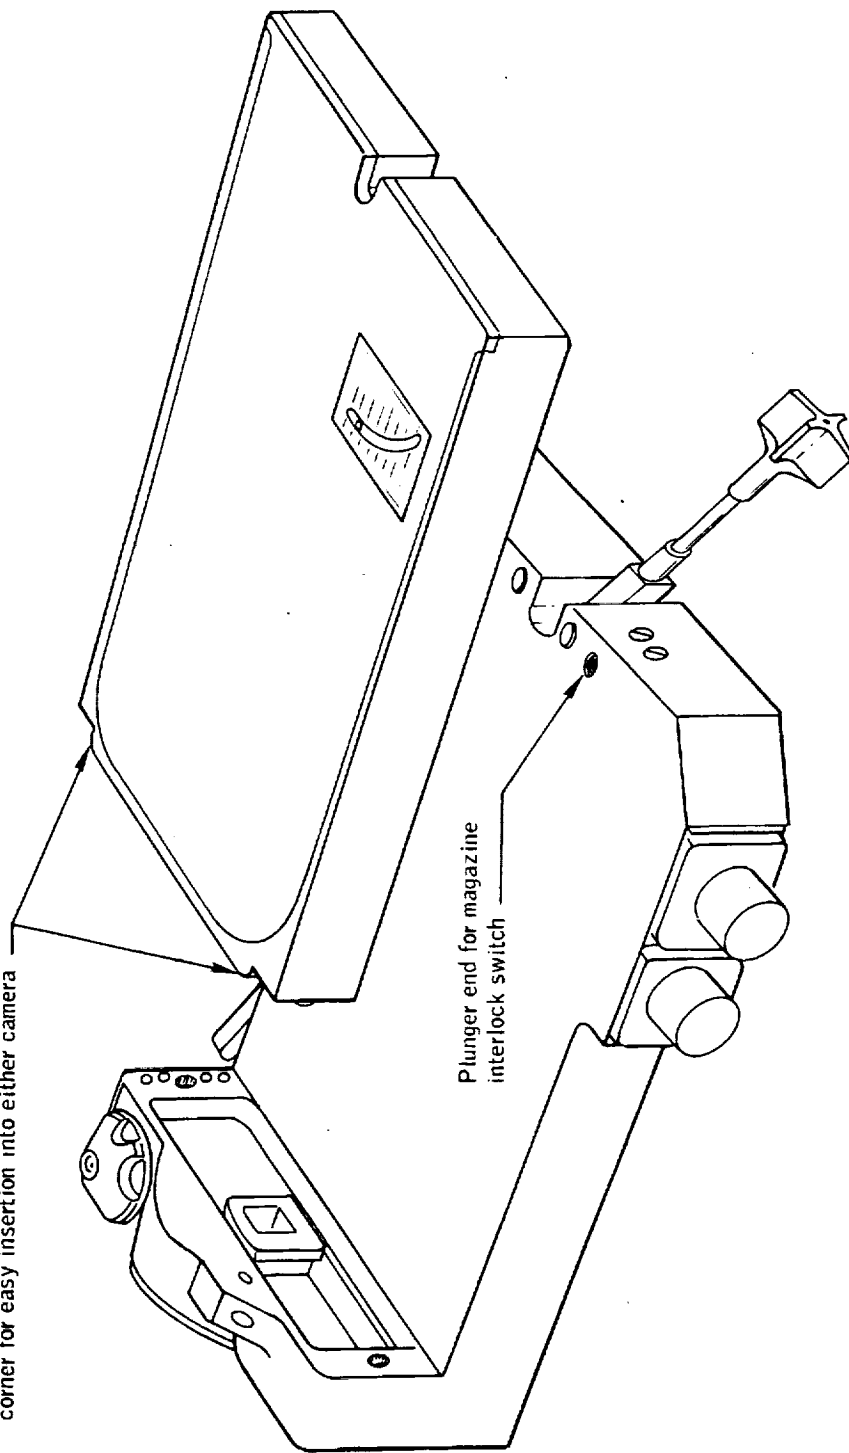
Figure 15-46.- Magazine installation in 16-mm cameras.

Radii on edges to be large enough to relieve corner for easy insertion into either camera

and edges. All magazines for subsequent missions will be selected for adequate clearance on the interface edges for a satisfactory fit to either camera (see fig. 15-46).

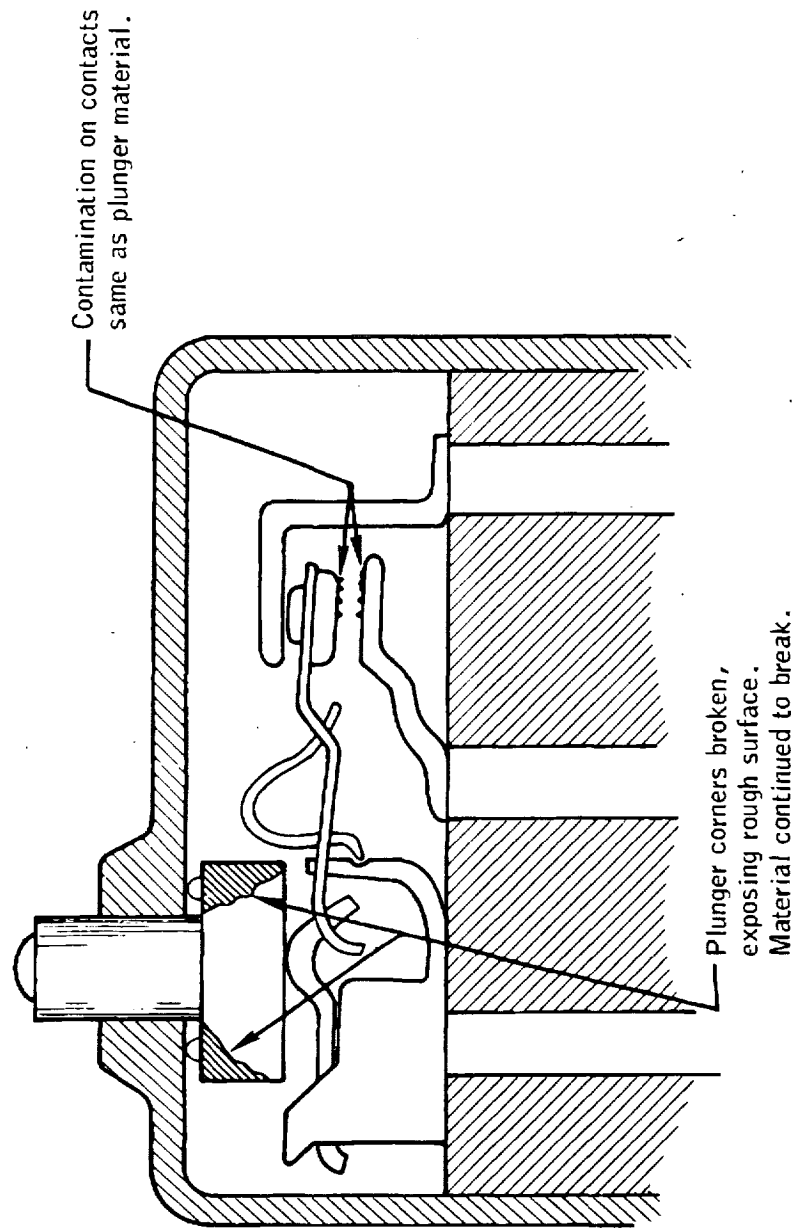
Figure 15-47.- Magazine interlock switch.

At approximately 173 hours, during transearth coast, the command module 16-mm camera ceased to operate in the pulse mode because the magazine interlock microswitch failed. The switch was not a high reliability item and failed because of internal contamination and a faulty plunger (fig. 15-47).
